Quinquennial Report  
Pulford, St Mary's Church

1.1 This is a report on a visual inspection of St. Mary's, Pulford. St Mary's is within the Diocese of Chester under the care of the Archdeacon of Chester.

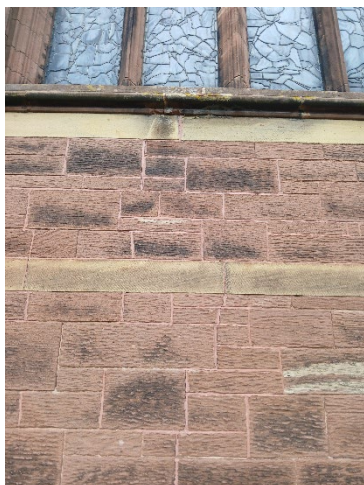
- 3.2.2 The vertical crack noted in the previous QI beneath the west window which is visible internally and externally does not appear to have changed since the previous QI. The crack has previously been re-pointed and at the moment is not a significant concern but should be monitored.

*Crack beneath west window*

| Ref | Description of Required Works | Priority Category | Prof. help | Approximate Cost (£) | | | | | Implication if Work is Deferred or Postponed |
|---|---|---|---|---|---|---|---|---|---|
| 3.2.2 | Monitor west gable crack | Monitor | | | | | | | |

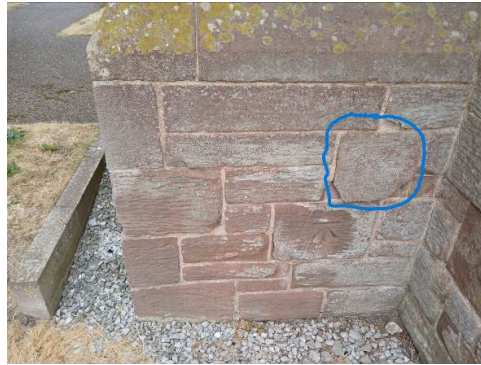
- 3.2.3 The stonework at low level around the perimeter of the Church was brushed back to remove loose areas of decay, and loose cement pointing has been replaced with lime mortar prior to the 2016 QI. Isolated areas of cement pointing remain but removal is likely to damage the adjacent stonework; as cement pointing becomes loose in the future it should be removed and replaced with lime mortar, which is breathable and will help arrest decay of the stonework. There are a small number of isolated areas of delamination and open jointing at low level; loose stone should be lightly dressed back to remove water traps and aid weathering, and open joints pointed in lime mortar.

*Example of delaminated loose face to stone*

| Ref | Description of Required Works | Priority Category | Prof. help | Approximate Cost (£) | | | | | Implication if Work is Deferred or Postponed |
|---|---|---|---|---|---|---|---|---|---|
| 3.2.3, 3.2.5 | Masonry works – minor repointing, stone consolidation, brushing back of loose stone to eliminate water traps | D | | | | £2,000 | | | Further decay |

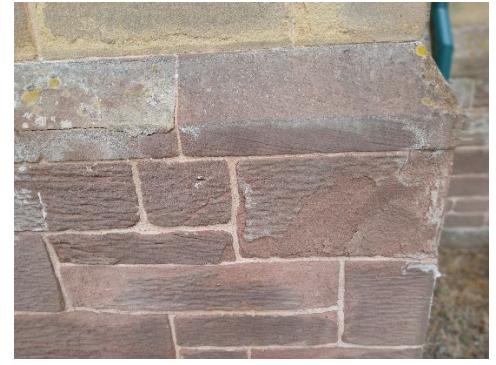
*Example of delaminated face to stone*

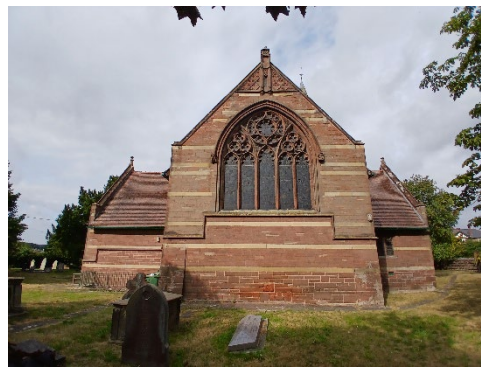
*East gable*

The stonework to the south and west elevations of the tower at mid-high level is now in good condition following the repointing carried out prior to the last QI. There is some open jointing to the north and east elevations of the tower, including to the buttress on the NE corner. Whilst not sufficiently extensive to warrant action within the next quinquennium, funds should be set aside for some repointing work within the next 10 years or so.

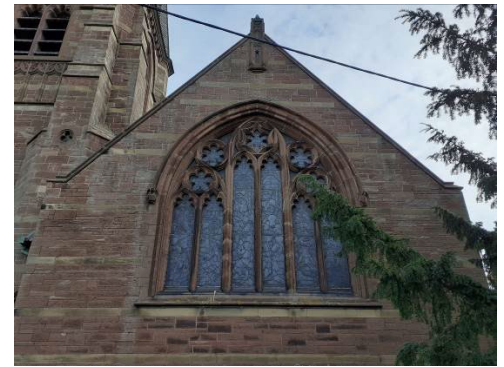
*West gable*

A small area on the west gable to the north side of the west window at high level has open jointing and requires repointing. This is not urgent and should be done when access is next available for another reason.

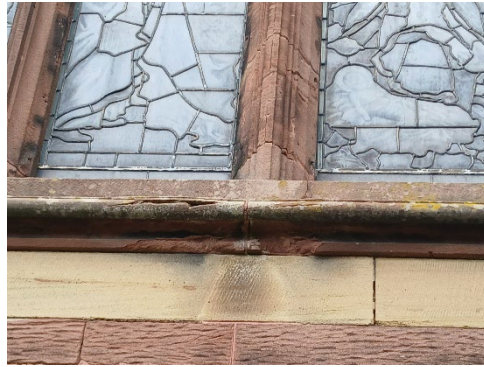
There is decay to the stone cill moulding below the west window, some minor open jointing to the mullions, and decay to the RHS of the hood mould, which has been partially filled previously. Open jointing should be repointed, and decay should be slowed by carefully filling water traps with a soft lime mix to exclude weather.

*Decay to stone cill moulding below west window*

| Ref | Description of Required Works | Priority Category | Prof. help | Approximate Cost (£) | | | | | Implication if Work is Deferred or Postponed |
|---|---|---|---|---|---|---|---|---|---|
| 3.2.6 | Masonry work around west window | D | | | | £1,000 | | | Further decay |

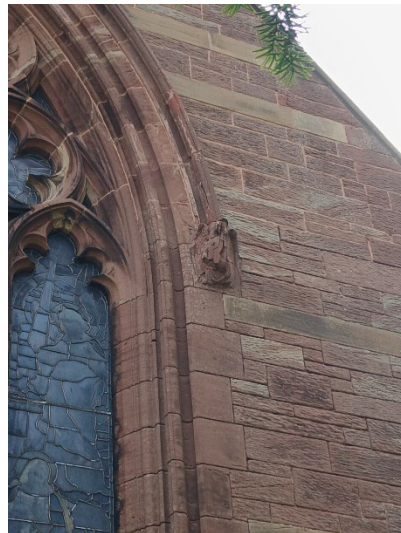
There is decay to the stone figurehead to the RHS of the hood mould over the window to the south side of the chancel, and other figureheads are also suffering decay, for example that to the RHS of the west window. A specialist stone conservator should be asked to make recommendations for consolidation, which may involve use of nano-lime. A very good recording should be made of the figureheads now for future reference.

*Figurehead to RHS of west window*

| Ref | Description of Required Works | Priority Category | Prof. help | Approximate Cost (£) | | | | | Implication if Work is Deferred or Postponed |
|---|---|---|---|---|---|---|---|---|---|
| 3.2.7 | Consolidation of eroded figureheads | D | Y | | | £2,000 | | | Further decay |

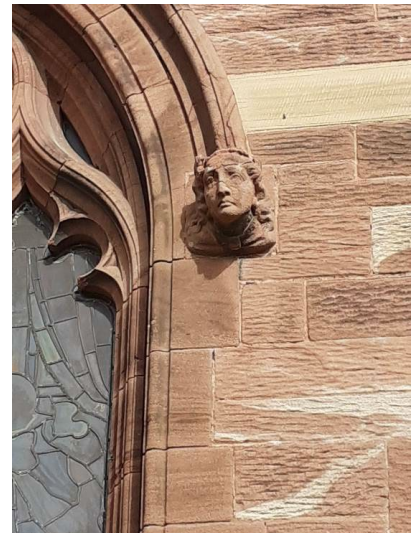
*Figurehead to RHS of window to south side of chancel*

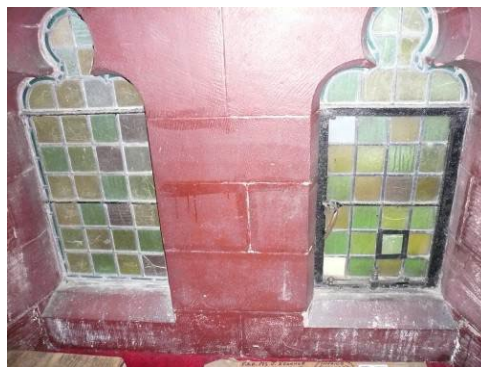
*Window in bellringing chamber*

It was noted that seven of the small pane leaded lights in windows serving the bellringing chamber are cracked, and one of the small panes is held in place with sticky tape. Whilst not an immediate priority, this should be repaired when the opportunity allows.

| Ref | Description of Required Works | Priority Category | Prof. help | Approximate Cost (£) | | | | | Implication if Work is Deferred or Postponed |
|---|---|---|---|---|---|---|---|---|---|
| 3.3.1 | Repair bell chamber window | F | | | | | | £375 | |

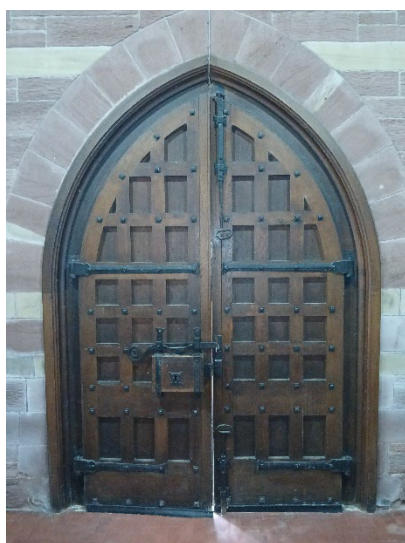
*Front (internal face)*

Externally there is a timber front double door, and a rear exit door from the vestry. External doors are in good working order but require redecoration of both the timberwork and the ironmongery externally in the next quinquennium. The base of the doors are becoming weathered and the ironmongery is beginning to corrode. The doors should be decorated with a breathable wood stain in matching colour rather than a hard varnish. The ironmongery requires rubbing down, the corrosion treating with a proprietary rust inhibitor, and the metalwork recoated with a zinc rich primer, prior to application of topcoats.

| Ref | Description of Required Works | Priority Category | Prof. help | Approximate Cost (£) | | | | | Implication if Work is Deferred or Postponed |
|---|---|---|---|---|---|---|---|---|---|
| 3.3.2 | Redecorate external doors | D | | | £1,500 | | | | Deterioration |

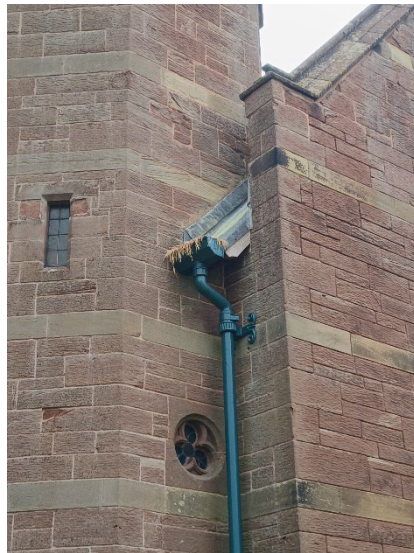
3.4.2 Gutters must be cleaned out periodically, especially after the autumn, and regular checks made to ensure they are free-flowing. A short gutter adjacent the tower was full of vegetation on the day of inspection.

*Newly decorated rainwater goods, blocked gutter*

| Ref | Description of Required Works | Priority Category | Prof. help | Approximate Cost (£) | | | | | Implication if Work is Deferred or Postponed |
|---|---|---|---|---|---|---|---|---|---|
| 3.4.2 | Clear blocked gutters | M | | | | | | | Saturated walls, deterioration |

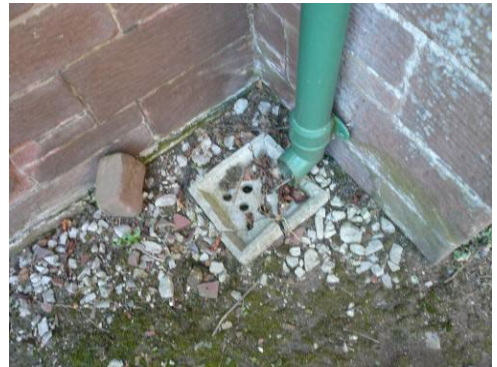
*Cracked gully*

| Ref | Description of Required Works | Priority Category | Prof. help | Approximate Cost (£) | | | | | Implication if Work is Deferred or Postponed |
|---|---|---|---|---|---|---|---|---|---|
| 3.4.1 | Repair gulley | F | | | | | | £225 | |

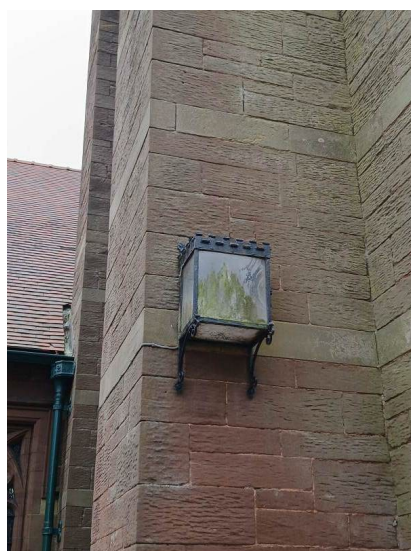
3.6.3 The metal light fittings still require redecoration.

*Light fitting requiring redecoration.*

| Ref | Description of Required Works | Priority Category | Prof. help | Approximate Cost (£) | | | | | Implication if Work is Deferred or Postponed |
|---|---|---|---|---|---|---|---|---|---|
| 3.6.3 | Redecorate external light fittings | D | | | £500 | | | | Advanced corrosion leading to need for replacement components |

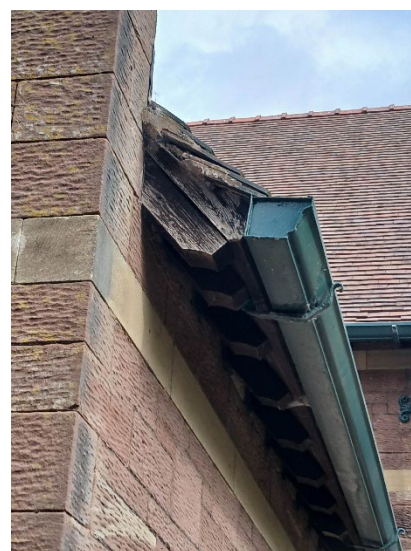
3.6.4 Whilst the exposed rafter feet are well protected from weather beneath the eaves, at the gable ends the end rafters are exposed to weather. Previous coatings of stain have largely weathered away, and to keep the end exposed rafters in good condition they require protecting with a breathable wood stain in matching colour.

*End rafters requiring re-staining for protection*

| Ref | Description of Required Works | Priority Category | Prof. help | Approximate Cost (£) | | | | | Implication if Work is Deferred or Postponed |
|---|---|---|---|---|---|---|---|---|---|
| 3.6.4 | Re-stain exposed rafter feet at gables | D | | | £250 | | | | Deterioration |

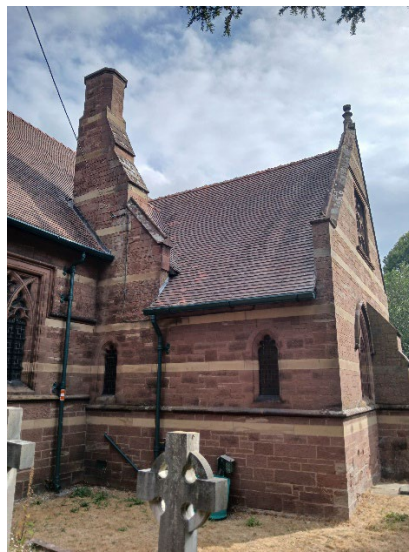
There is a slipped tile to the north roof slope, and two slipped tiles to the corner of the west roof slope of the north transept. These were noted in the previous QI and have not been addressed. There are also two broken roof tiles near the ridge to the west roof slope of the north transept. There is a broken roof tile to the east roof slope of the north transept, and the verge has dropped adjacent the gutter. There are two slipped roof tiles to the east side of the south roof slope adjacent the chimney. There are two slipped tiles and a broken tile to the west roof slope of the south transept. There are some loose / broken tiles to the roof slope either side of the chimney.

*Two slipped tiles and broken tile to west roof slope of the south transept*

| Ref | Description of Required Works | Priority Category | Prof. help | Approximate Cost (£) | | | | | Implication if Work is Deferred or Postponed |
|---|---|---|---|---|---|---|---|---|---|
| 3.7.2 | Address slipped and broken tiles to roof, reset dropped verge. | B | | £2,000 | | | | | Deterioration, roof failure |

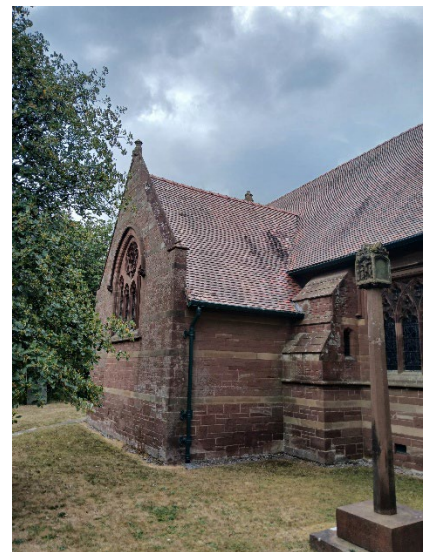
*Two slipped and two broken roof tiles to west roof slope of the north transept*

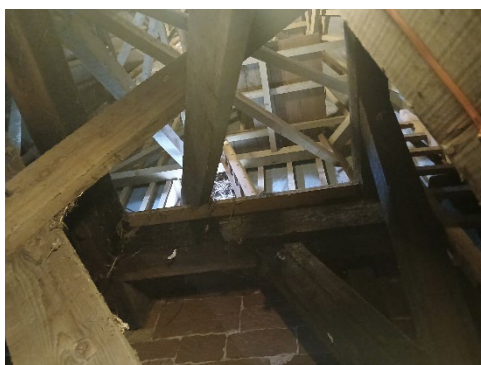
- 4.1.6 Birds have begun accessing the spire / bell chamber again and the source of entry should be established and netting reinstated to prevent future access. Sticks and debris will require removal from the bell chamber again once the source of entry is closed off.

*Evidence of birds nesting in spire*

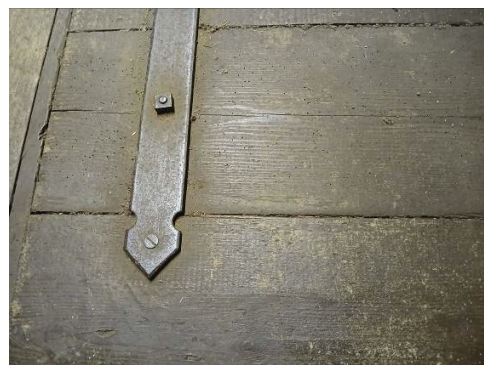
- 4.1.1 The signs of woodworm noted in the previous Quinquennial Reports in the floor and beams supporting the belfry does not appear to have worsened, suggesting no active infestation. Timbers are dry. Comparisons should be made with the photograph below over the course of the next 5 years and proprietary treatment applied locally if any changes are noted.

*Woodworm/furniture beetle damage assumed no longer active*

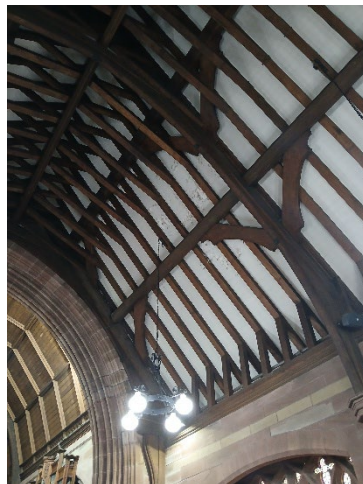
- 4.2.2 There is an area of what appears to be flaking paint over the pews to the south side of the nave, maybe due to the application of modern paint over an earlier limewash or distemper, but it is unclear why this isolated area is affected. Access should be provided for a touching-distance inspection to check the security of the ceiling panels, and the affected area rubbed down back to a sound surface and redecorated with a breathable finish. Other parts of the nave ceiling, and the ceiling of the north transept would benefit from redecoration for cosmetic reasons.

*Flaking paint to ceiling over nave*

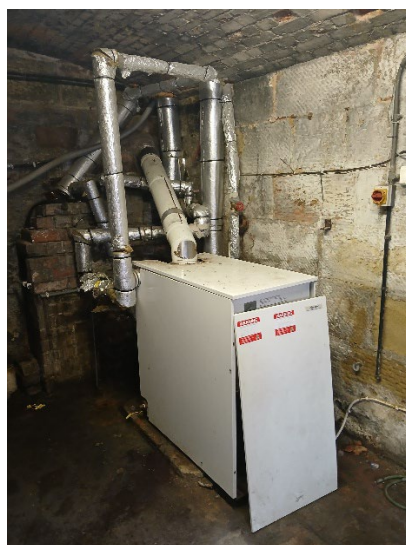
*Boiler room*

5.1.1 The boiler was replaced in 2007 with an oil-fired Worcester Bosch unit serving a low-pressure hot water system, utilizing the existing pipework and heater emitters. At the time of inspection the boiler was not working and a new part was awaited for its repair.

5.1.2 The boiler is located in the basement below the vestry which is essentially an outdoor unheated space. A frost stat is fitted adjacent to the boiler and the pipework is insulated. The window to the basement has been reglazed in recent times. The basement is damp, as expected, and this is mitigated by keeping it well ventilated.

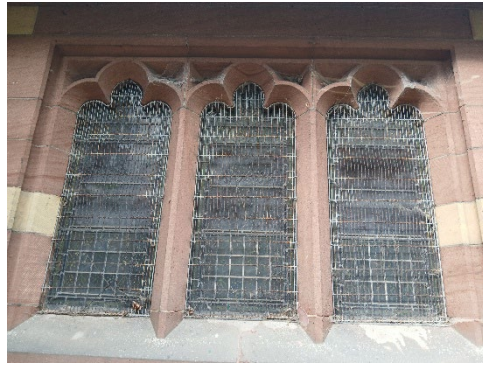
- 6.3.4 There are no security grilles over the windows aside from the grille over the window in the north transept, which is of mild steel and is corroding away. This decorative stained glass window is of high significance, with the theme of 'childhood' across three lancets. The church should carry out a risk assessment and consider installation of new protection if thought appropriate, especially to the decorative windows of high significance. There is stained glass by Heaton Butler and Bayne elsewhere in the church. It is recommended that any new security grilles should be of stainless steel mesh with powder coat finish, and fixed into mortar joints with non-ferrous fixings.

*Corroded security grille*

| Ref | Description of Required Works | Priority Category | Prof. help | Approximate Cost (£) | | | | | Implication if Work is Deferred or Postponed |
|---|---|---|---|---|---|---|---|---|---|
| 6.3.4 | Window security grilles | D | Y | | £1,000 | | | | Risk assessment required, cost is for replacement of one corroded grille |

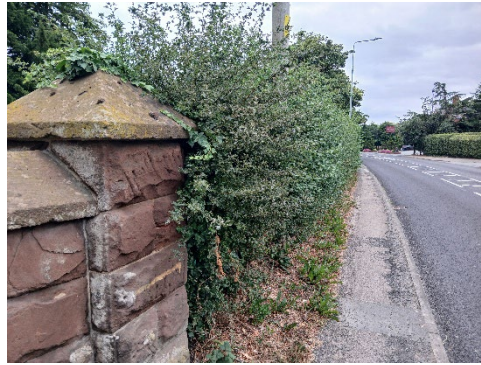
*Hedge adjacent road*

- 7.4.1 The timber post and rail fence to the south and east sides is generally in good condition: some lengths have been replaced in recent times. The beech hedge to the east and south sides, planted prior to the previous QI, has established well. There is a small timber gate to the east side of the churchyard, installed about 10 years ago. The church warden reported that the church had received a request to trim the hedge bordering the pavement next to the road, and this is an important H&S consideration to maintain a good width to the pavement.

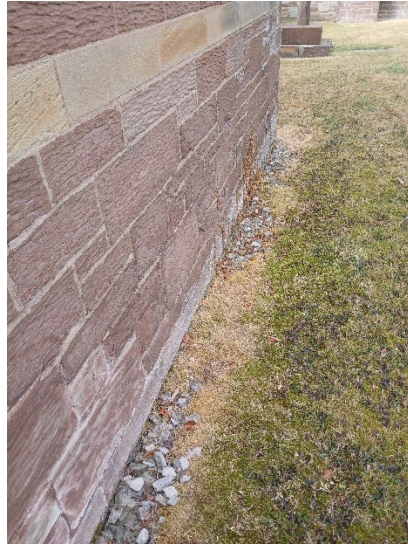
There is a gravel or 'French drain' arrangement around the perimeter of the Church and this must be kept clear of vegetation to reduce likelihood of damp internally.

*Vegetation in French drain gravel.*
